Masury Estate Ballroom
Interior Mural Assessment & Documentation

September 20, 2021

Prepared By:
John Canning & Co., Ltd.
150 Commerce Court
Cheshire, CT 06410

Prepared For:
Holiday Beach Property Owners Association
67 Old Neck Road South
Center Moriches, NY 11934

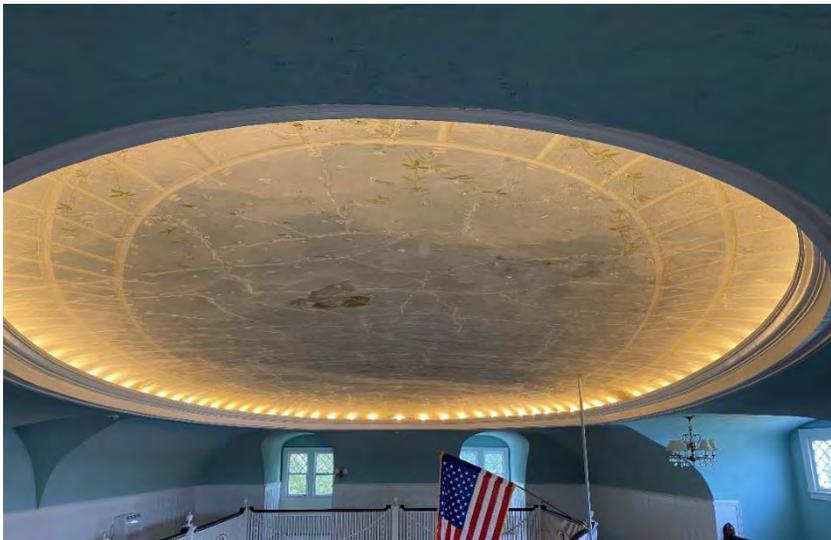
Overall, the plaster substrate is in fair-to-poor condition. About one-third of the ceiling, from the center of the mural moving westward, is sagging (fig. 2). There is a network of cracks and many right-angle cracks running all over the mural, ranging in width from hairline to 1/8" (fig. 3). This indicates that the plaster keys in the wood lath may have deteriorated, or the furring that runs perpendicular to the lath may be compromised. However, the cause of the cracks can only be confirmed after access to and examination of the structural support for the ceiling. Several areas of the mural sound hollow and exhibit movement. Some newer cracks appear to have formed mainly in the northwest corner and north side. Additionally, there is an almost rectangular panel that is delaminated on the north side, right above the recessed lighting (fig. 4).

Figure 2. Overall image of the ceiling sagging, looking west (Photo by JCC, Sept. 2021)

1. The back/support of the ceiling mural must be accessed and assessed to determine the cause of the sag and cracks in the mural. If it is determined to be a structural issue, then this must be treated first, prior to any work on the face of the mural. Depending on the diagnosis, a separate contractor may be needed to perform the necessary repairs and stabilization.

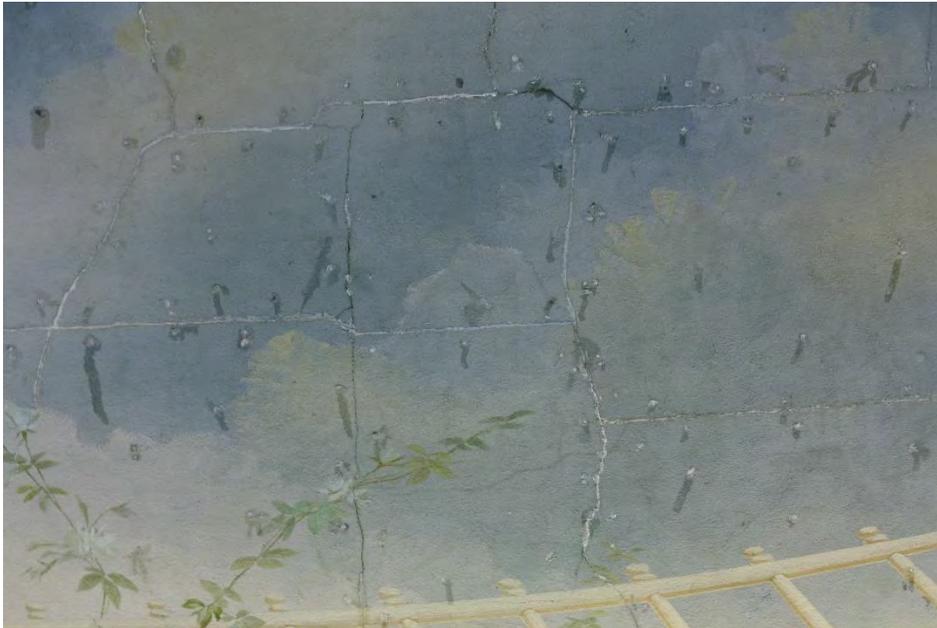
Figure 3. Overall image of the map cracking as well as stains appearing like drip marks (Photo by JCC, Sept. 2021)

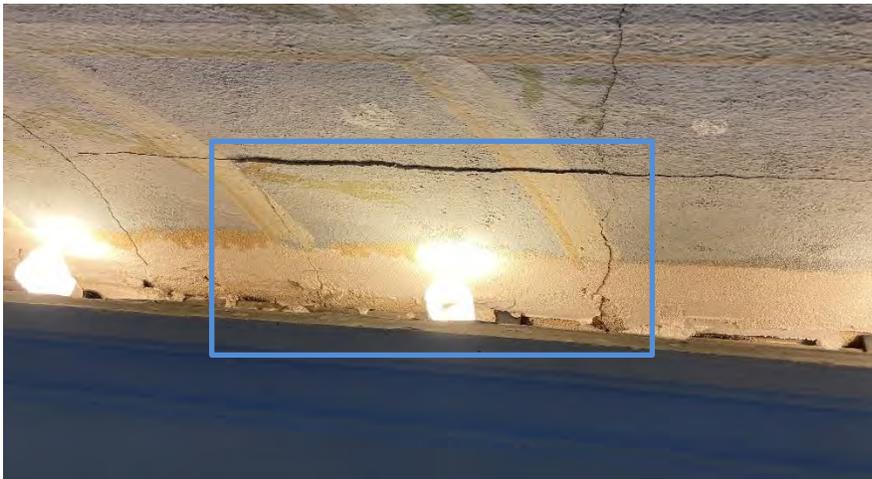
Figure 4. An almost rectangular panel of delaminating plaster, denoted by the blue box (Photo by JCC, Sept. 2021)

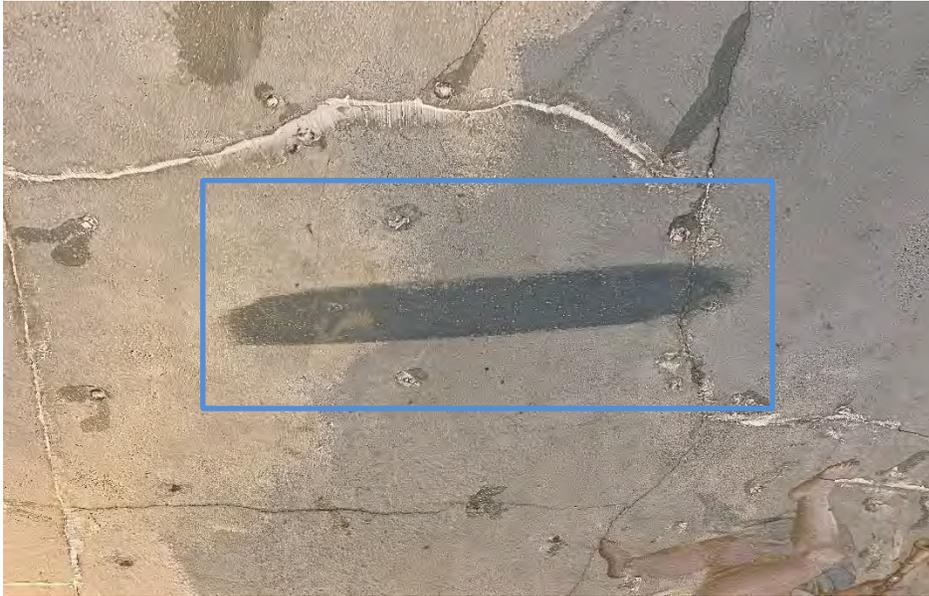
Overall, the paint is in fair-to-poor condition. There is a thin layer of a chalky white deposit, or efflorescence, throughout the entire surface of the mural. A test of brushing water on the surface shows what the original color of the background should be (fig. 5). Paint loss and tenting and flaking paint can be seen where there is major efflorescence on the northern half of the mural

Figure 5. The highlighted area shows where water was brushed on the surface to show what the original color should look like (Photo by JCC, Sept. 2021)

- Clean, consolidate, and re-saturate the paint layer. The thin, efflorescence layer on the paint surface will be re-constituted and the mural stabilized before the following treatment can take place.

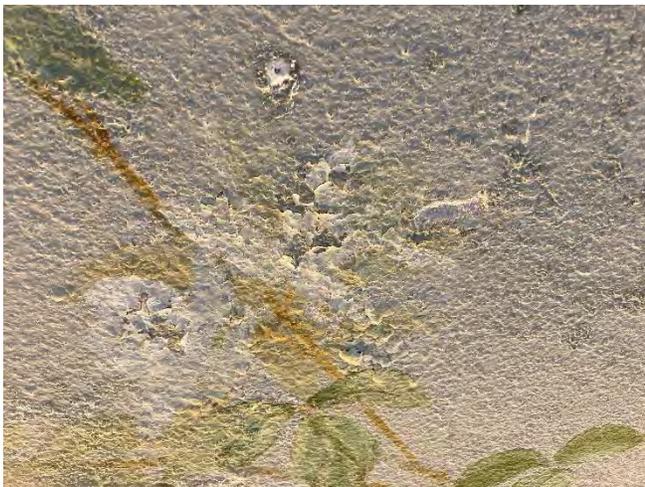
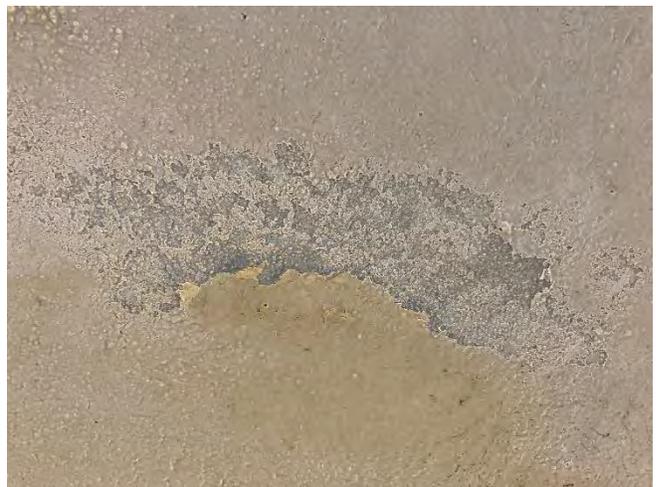
(figs. 6&7). There is minor biological growth on the northeast quadrant of the mural (fig. 8) and on a couple other localized areas. Biological debris is also visible throughout the surface of the mural. The original paint layer is fairly intact and there does not appear to be any overpaint.

Figures 6 and 7. Detail of paint loss, tenting and flaking paint (Photos by JCC, Sept. 2021)

- Remove degraded or failing material from the drill holes and cracks; inject with plaster consolidant, if needed.
- Infill areas of loss and inpaint with conservation-grade (reversible) materials
- Apply protective coating

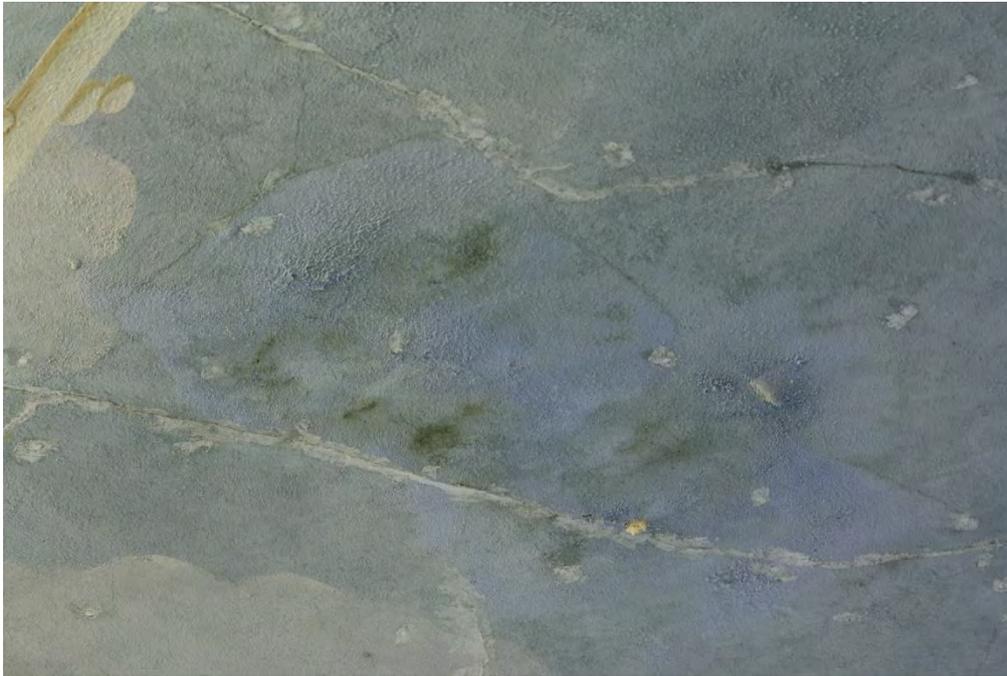
Figure 8. Detail of mold on the surface (Photo by JCC, Sept. 2021)

2. The areas of existing mold will require separate treatment: First, the cause of the mold will need to be determined. Less invasive methods can be used, e.g. a borescope, to access and view the back of the mural. From there, the appropriate treatment can commence. Generally, mold can be eliminated with alcohol and/or heat.

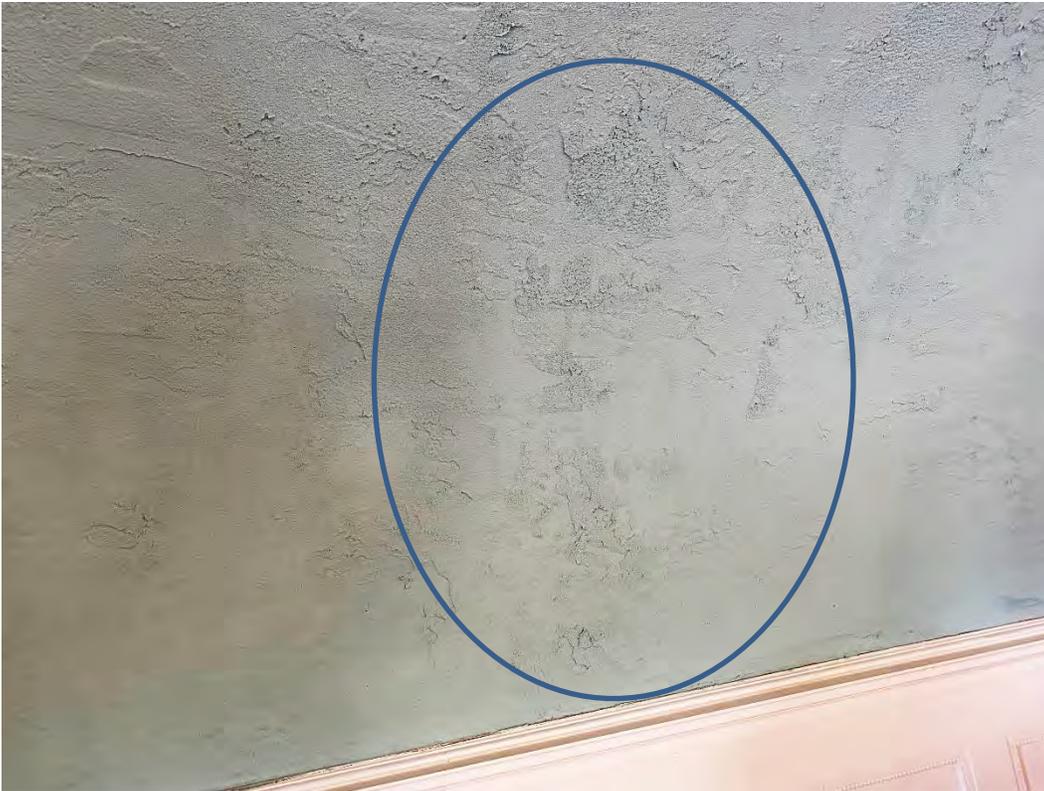
Figure 9. A ghosting of the harp pattern on the balcony walls, denoted by the blue circle (Photo by JCC, Sept. 2021)

For future recommendations of the Ballroom decoration, JCC recommends reinstating the harp pattern on the balcony walls, above the wainscot. This pattern can be seen in the historic photograph of the Ballroom and while onsite, a ghosting of the pattern can be seen through the current paint scheme (fig. 9).
